**Flood Control Project Maintenance**  
**2011 Structure Summary Report**  
**Overall Unit and Item Ratings**

**Reclamation District No. 0999 Netherlands**

**Elk Slough Inlet Structure**

**Flood Control Project Maintenance****Unit Cover Sheet****2011 Structure Inspection Results****Reclamation District No. 0999 Netherlands**

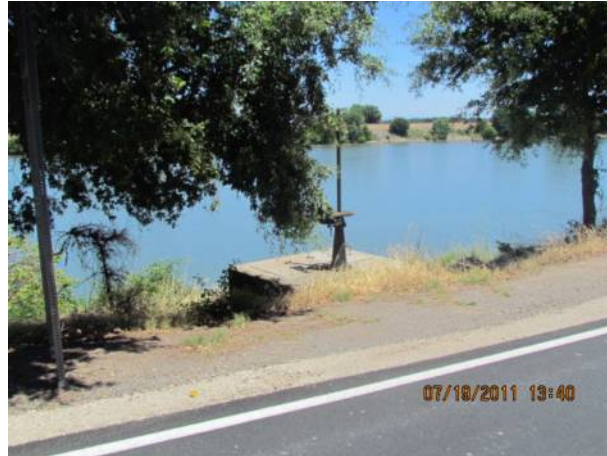
| richard_t_20110728_063.jpg | |

| LMR No. | Levee Mile | | Category | Item | Location * | Rating ** | Action/Comment | GPS Latitude/Longitude | | Issue No. |
|---|---|---|---|---|---|---|---|---|---|---|
| 1 | | | Structures | Photo Documentation | | | Inspector Comments: Structure appears to maintained and able to function as designed. | 38.414063 °<br>-121.523357 ° | 38.414063 °<br>-121.523357 ° | 1<br>Y |

| Looking east at manual gate on inlet side of structure. | |

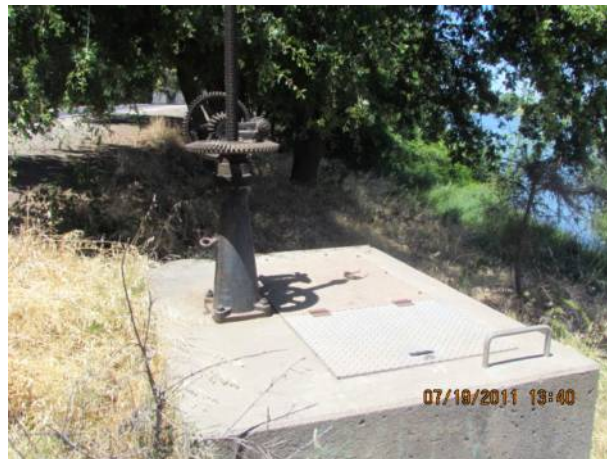
| richard_t_20110728_064.jpg | |

| Looking north on inlet side at manual gate and concrete box. | |

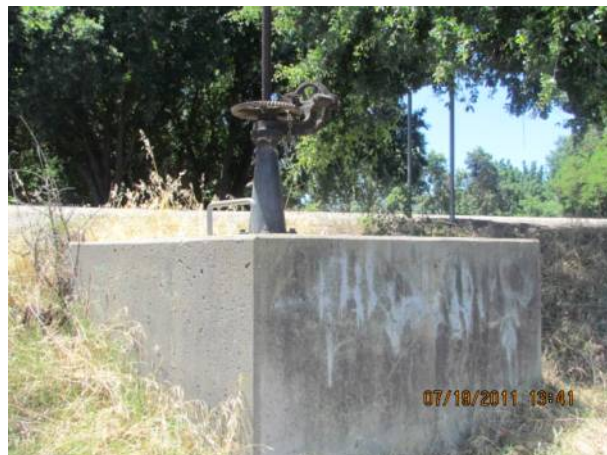
| richard_t_20110728_065.jpg | |

| Looking northwest on inlet side at manual gate and concrete box. | |

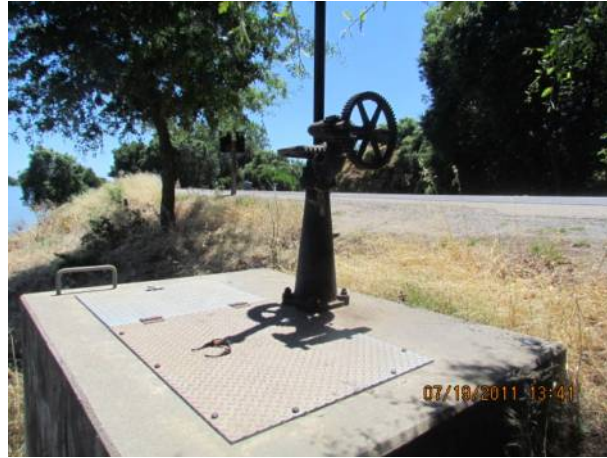
| richard_t_20110728_066.jpg | |

| Looking southwest on inlet side at manual gate and concrete box. | |

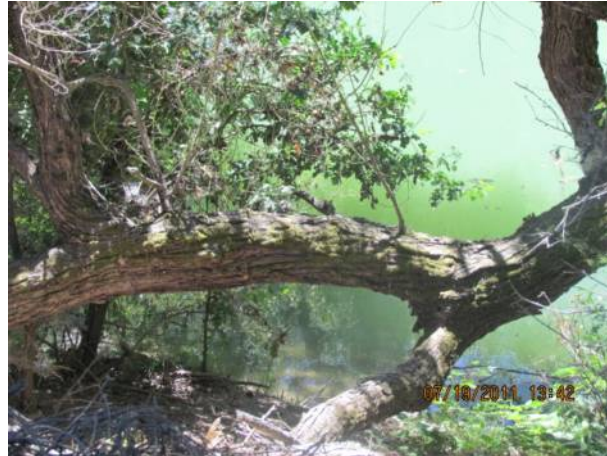
| richard_t_20110728_067.jpg | |

| LMR No. | Levee Mile | | Category | Item | Location * | Rating ** | Action/Comment | GPS Latitude/Longitude | | Issue No. |
|---|---|---|---|---|---|---|---|---|---|---|
| 7 | 0.00 | 0.00 | Structures | Culverts: Inlets / Outlets | | N | Inspector Comments: Culvert outlet not viewable due to water level. | 38.414063 °<br>-121.523357 ° | 38.414063 °<br>-121.523357 ° | 7 |

| Looking southwest on outlet side pipe not viewable due to water level. | |
